HISTORY OF A LANDSLIDE IN HEAVILY OVERCONSOLIDATED CLAY OVER AN ARTESIAN AQUIFER

Jesús Gómez¹, Ph.D., P.E.; Andy Baxter², P.G., MSCE, Helen Robinson³, P.E.,
Gerald Robblee⁴, P.E., G.E.

ABSTRACT

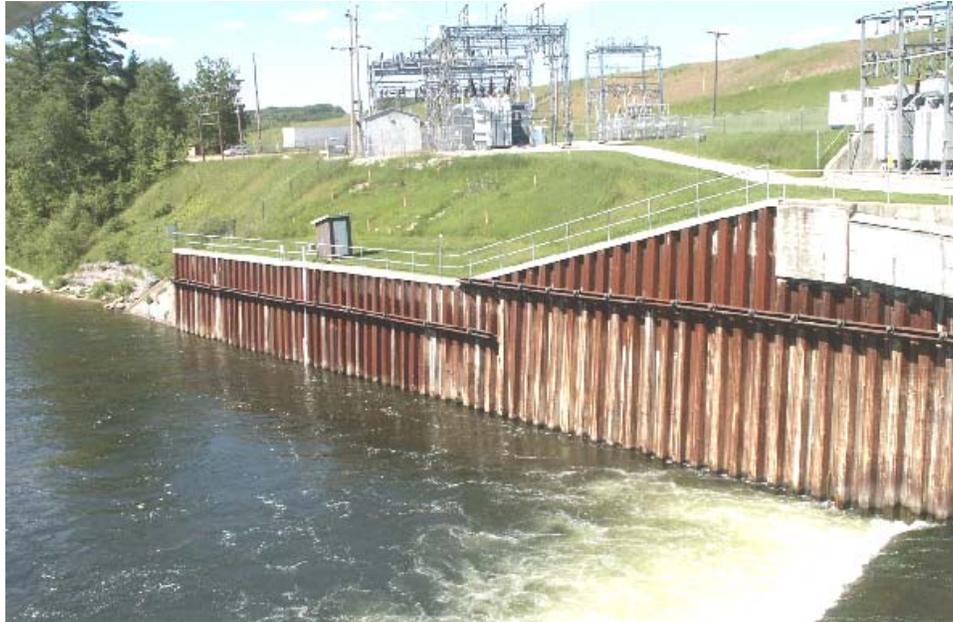
FIG. 1. View of the tailrace channel and east retaining wall in 2000-2001. Note the existing tiebacks installed in 1996. The sheetpiles were also added in 1996 as a facing and do not penetrate below the footing.

Tiebacks were installed in 1996 as depicted in Figure 1. Subsequent monitoring of the wall revealed continuous lateral displacements and the need for additional stabilization measures.

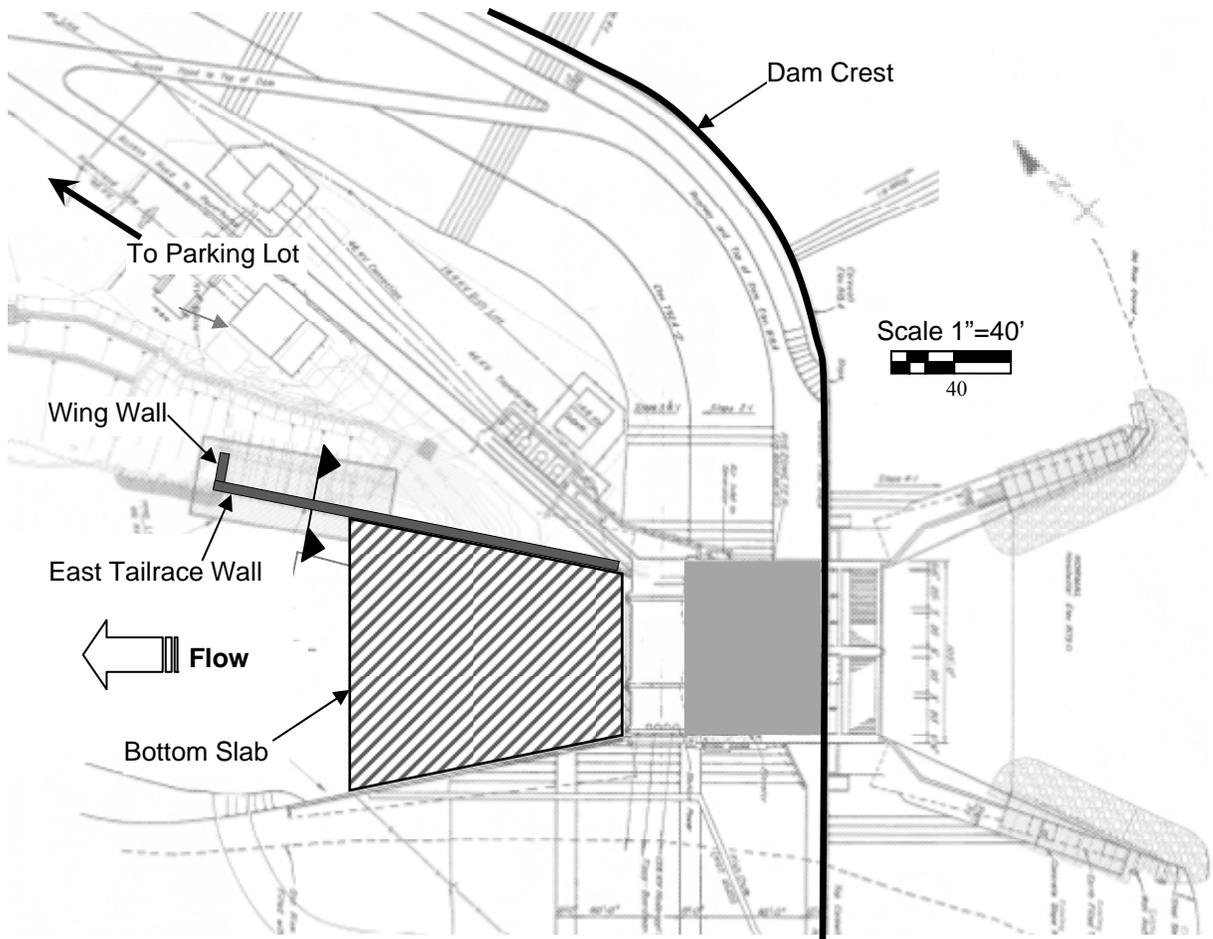
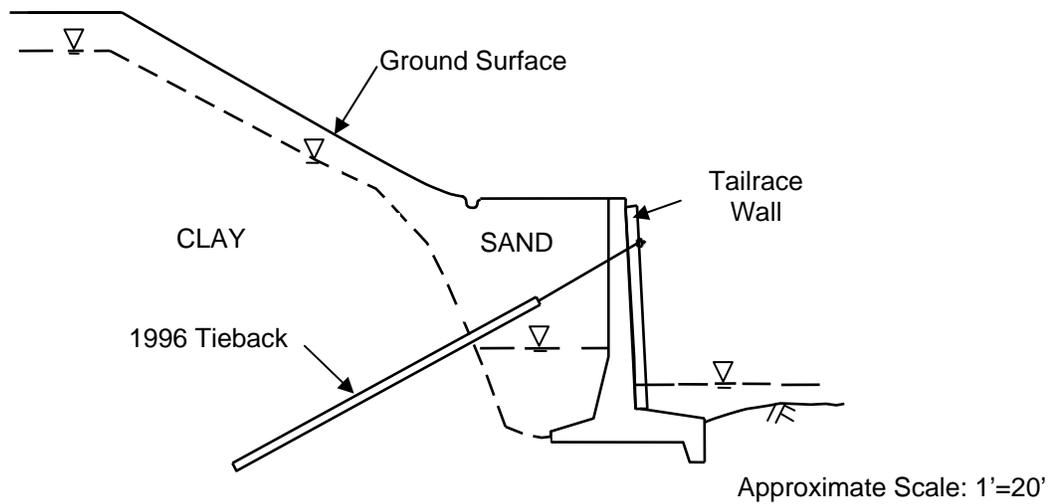
Figure 2 shows a general plan view of the site. The tailrace channel shown in Figures 1 and 2 was carved into natural soils during construction of the dam. The retaining walls on both sides of the channel were originally constructed as reinforced concrete cantilever walls. A bottom slab extends from the powerhouse to approximately the midpoint of the east wall. Natural clays are exposed in the bottom of the channel downstream of this slab.

During the 1996 remediation attempt, tiebacks were installed throughout the length of both walls as seen in Figure 1. The face of the walls were protected with sheetpiles bearing directly on the concrete footing of the wall and supported laterally by the tiebacks.

FIG. 2. General Site Plan and Section after 1996 remediation looking upstream.

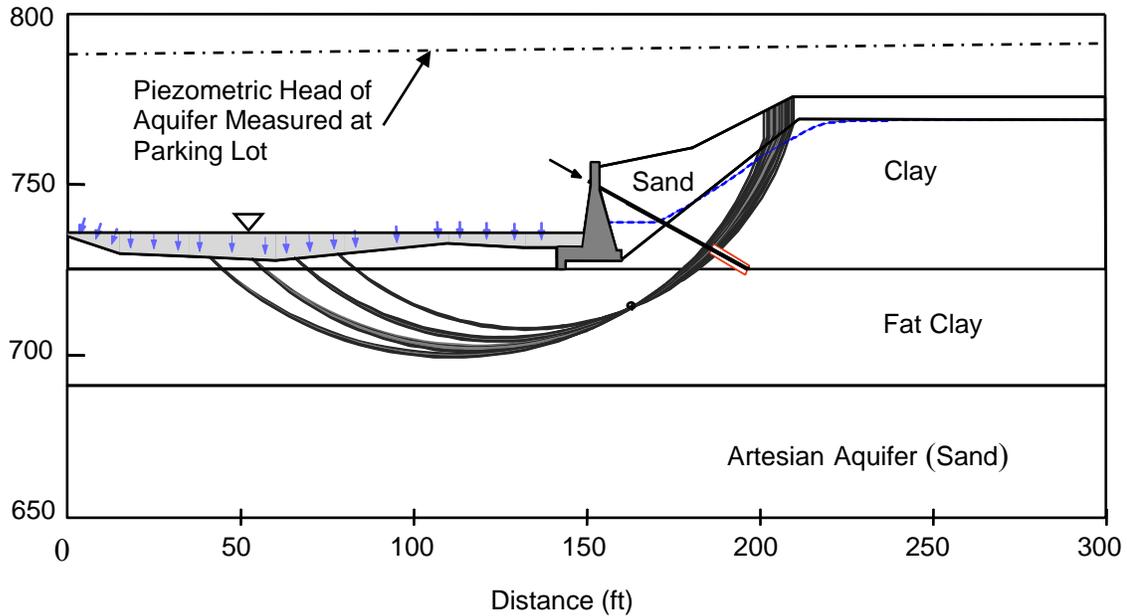
Figure 3 is a cross section of the east tailrace wall, which depicts the soil strata identified from the site explorations. The soils at the site consist of a shallow layer of sand extending to a depth of 5 ft. The sand is underlain by an interval of overconsolidated clay. The clay typically contained a fraction of fine to coarse sand and traces of gravel-size particles. Sporadic lenses and/or seams of sand were also detected at some locations within the clay mass. The results of the laboratory testing revealed that the plasticity of the clay materials increased with depth. An approximate and somewhat idealized boundary between low and high plasticity clay is represented in Figure 3.

FIG. 3. Typical Section through East Tailrace Wall looking Downstream.

Two mechanisms of sliding were analyzed. A circular slip surface using Morgenstern-Price Method was first considered as illustrated in Figure 3. Composite or block slide mechanisms were also analyzed using the modified

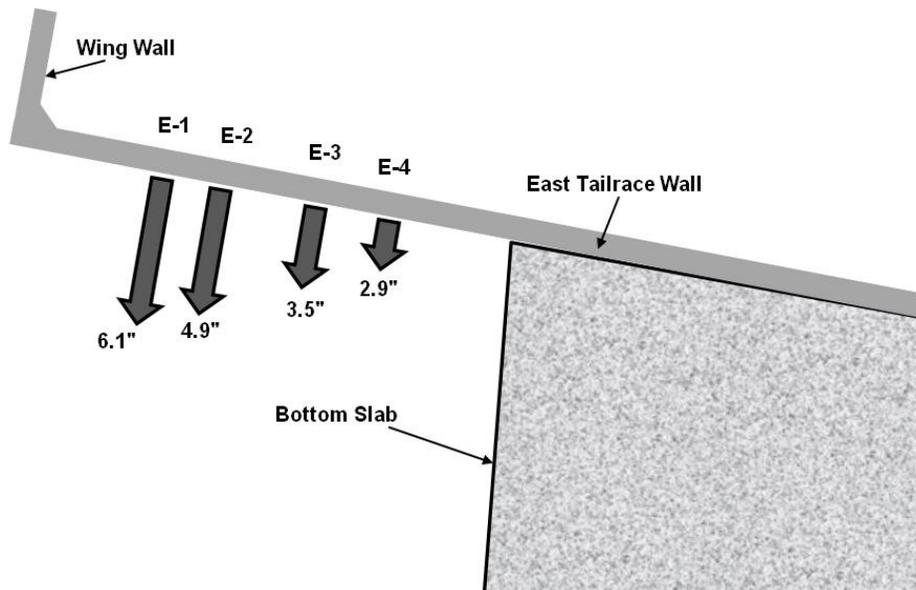
Figure 4 is a plan view showing the measured movement of the East Tailrace Wall. The magnitude of movement increases almost linearly in the downstream direction of the wall. Thus, the downstream end of the east wall rotates around a vertical axis located approximately at the termination of the bottom tailrace channel slab. It appears that the slab restrained lateral movement of the wall. In addition, it was found that the wall did not move downstream as observed in inclinometers.

FIG. 4. Magnitude of movement of the downstream end of the East Tailrace Wall.

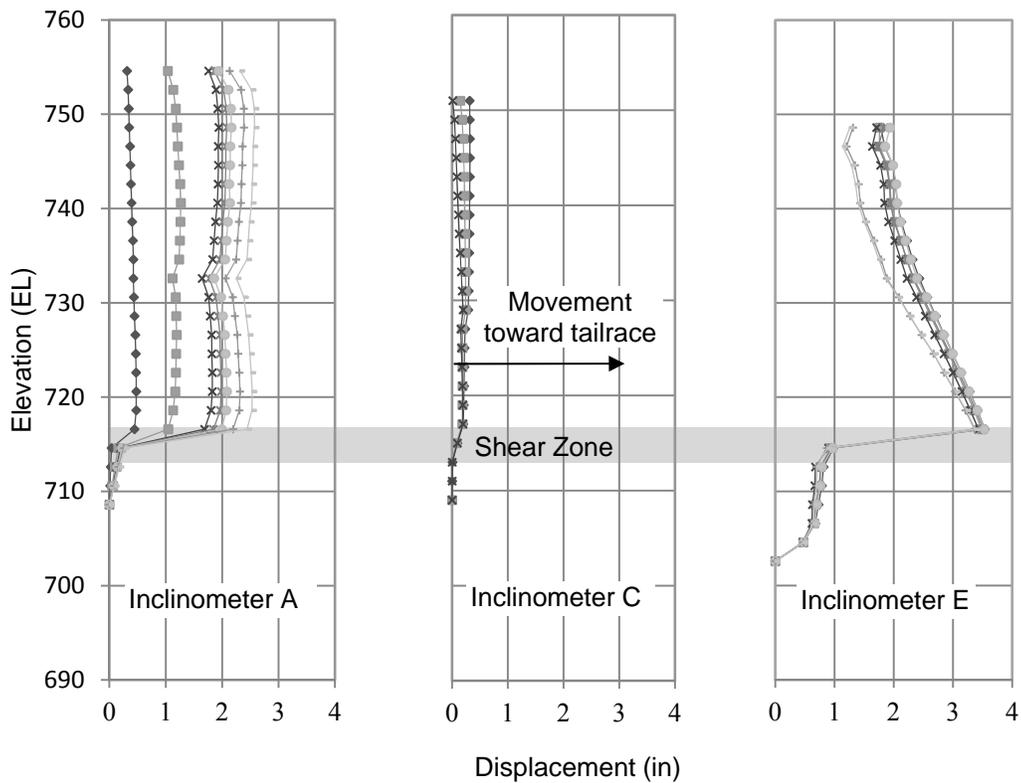
Figure 5 shows the measurements from various inclinometers installed behind the wall. The inclinometer data revealed the existence of a predominant slip surface located from EL 713 to 717. The inclinometer data also showed a significant downstream component of the movement.

FIG. 5. Selected Inclinator through the slip surface. Baseline data and last data reading for Inclinator A (4/2001-1/2009), Inclinator C (8/2009-7/2010), and Inclinator E (6/2005-11/2010).

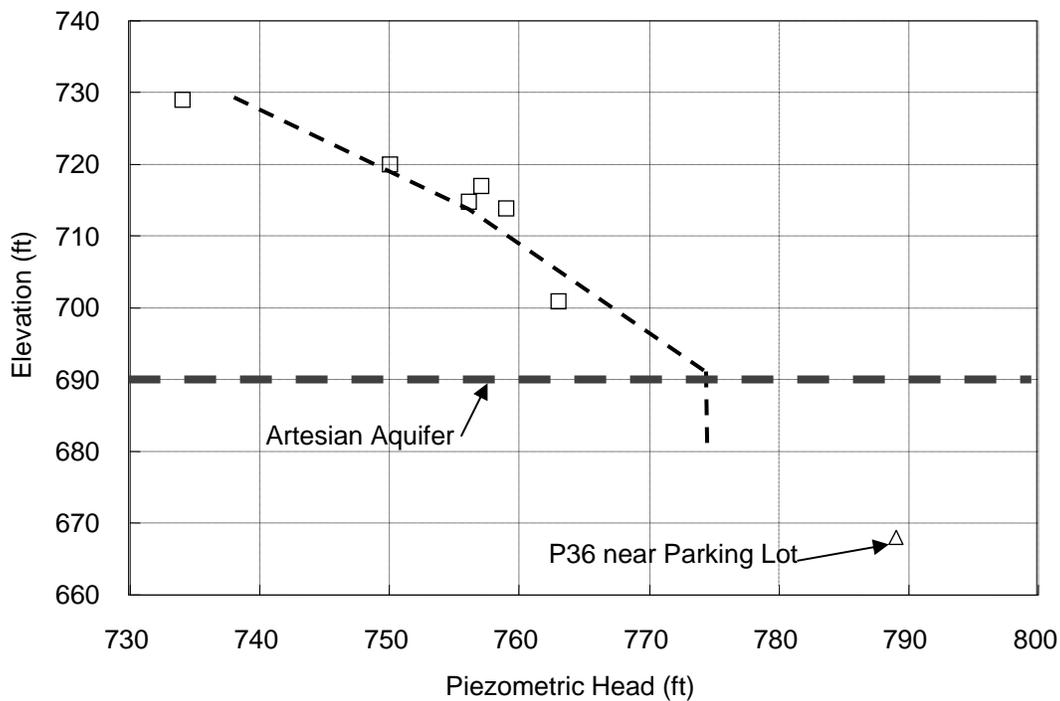
Figure 6 shows the piezometric head data inferred from pore pressure measurements from vibrating wire piezometers embedded at various elevations within the inclinometer grout. This data shows that there is a significant gradient from the artesian aquifer into the clay. It is possible that there are narrow seams of relatively permeable material within the clay that are connected to the artesian aquifer and where the piezometric head is even larger than that shown in the figure.

FIG. 6. Piezometric head data with depth showing effect of artesian aquifer below.

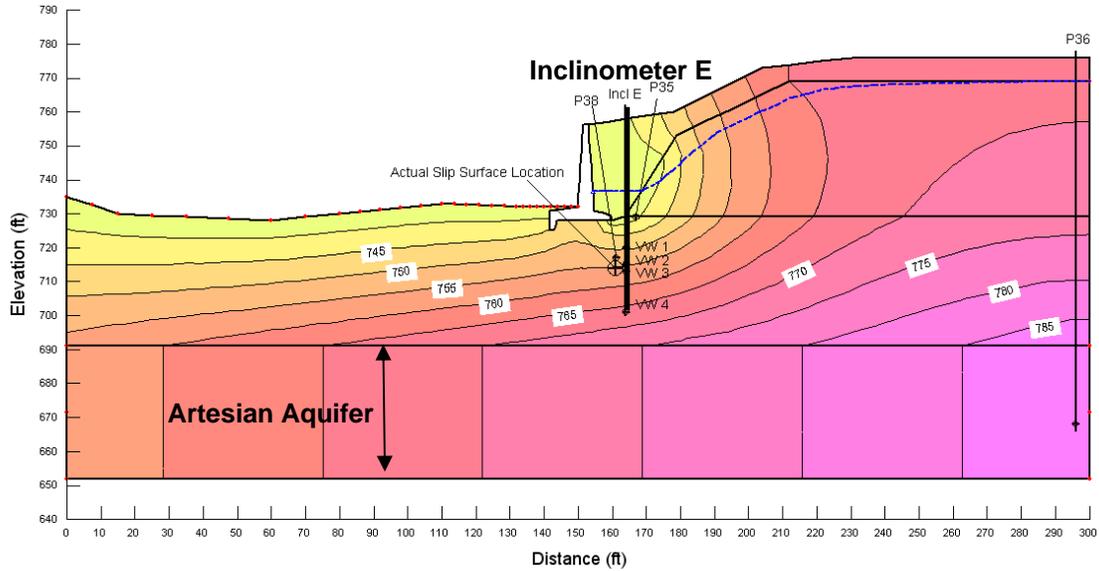
Figure 7 is a seepage analysis performed using SEEP/W, assuming a steady state flow condition across the clay layer. This analysis considers that there is a horizontal gradient across the aquifer. The reason for this assumption is that the piezometric head measured within the aquifer below the parking lot area could not be sustained in the tailrace channel area because the overlying, thinner clay stratum would heave under the sub-pressure. Also, it is likely that the piezometric head within the aquifer increased during construction and filling of the dam, which would create flow within the aquifer away from the dam embankment.

FIG. 7. Steady state seepage analysis output from SEEP/W.

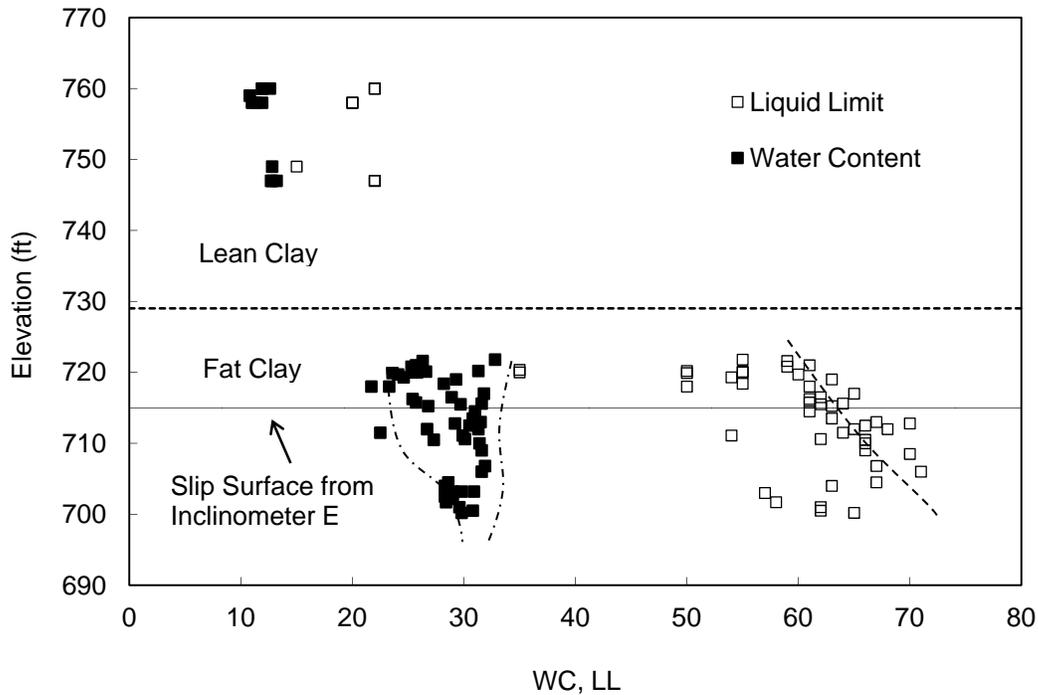
Figure 8 is a summary of Atterberg Limit tests on specimens of the overconsolidated clay stratum. The values of liquid limit and plastic index measured in the Lean Clay specimens differ significantly from those of Fat Clay specimens. Similarly, the measured values of liquid limit tend to increase with depth within the Fat Clay interval. The figure shows an idealized boundary differentiating low plasticity from high plasticity clay. The figure also shows the natural water content measured in the clay specimens. The measured water contents generally range between 20 and 32 percent and tend to increase with depth. It is interesting to note that the water content shows a larger scatter near the location of the slip surface.

FIG. 8. Atterberg limits and natural water content across clay stratum.

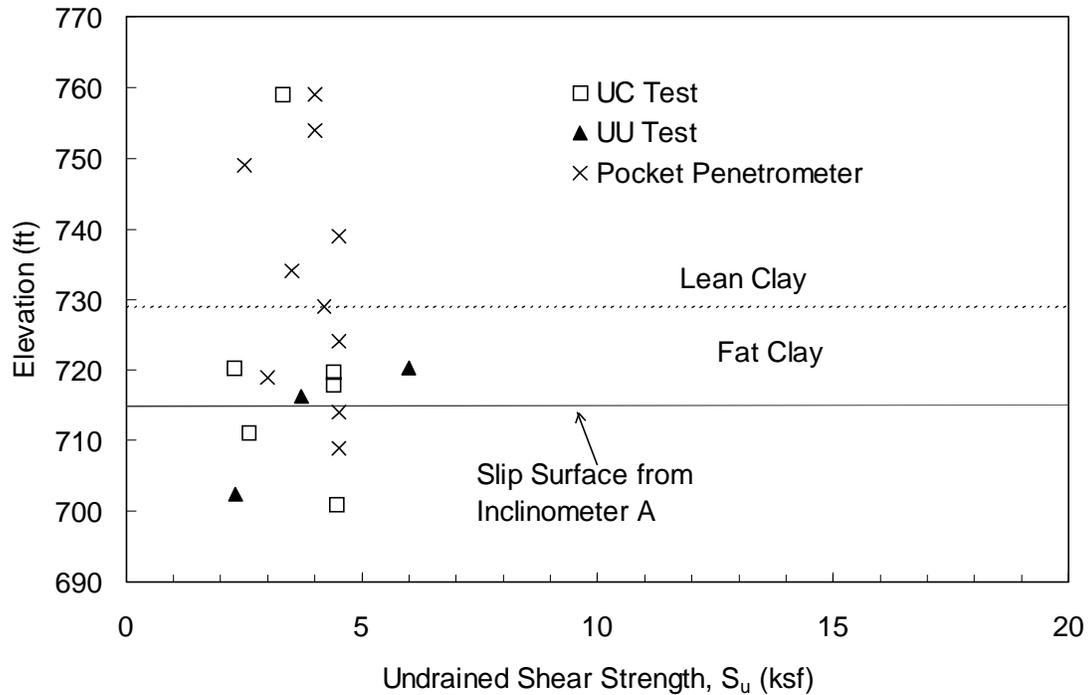
FIG. 9. Undrained strength across the clay interval interpreted from various laboratory tests.

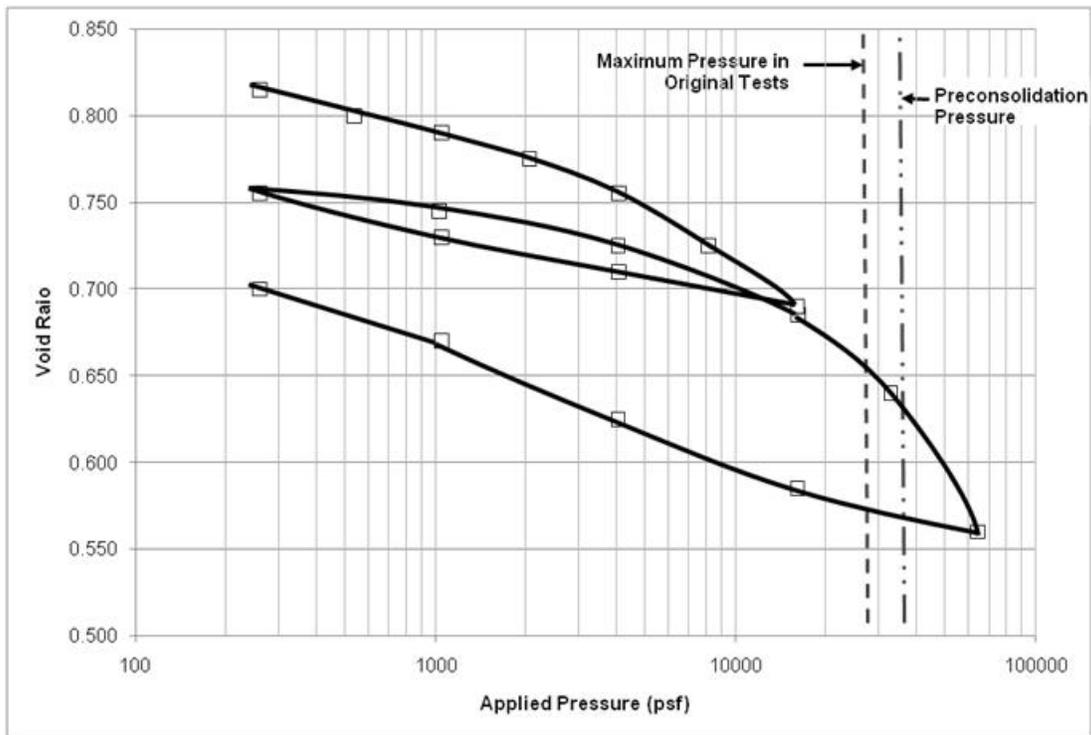
These results prompted the designers of the remediation to request additional consolidation tests under a larger range of consolidation pressures. A typical result is presented in Figure 10. The results of these new tests showed that preconsolidation pressures exceeded 30 ksf in most specimens, which yielded OCR values greater than 10 in most cases. It is important to note that the

maximum consolidation pressure was 64 ksf which was limited by the load capacity of the consolidation equipment.

FIG. 10. Consolidation test of fat clay sample.

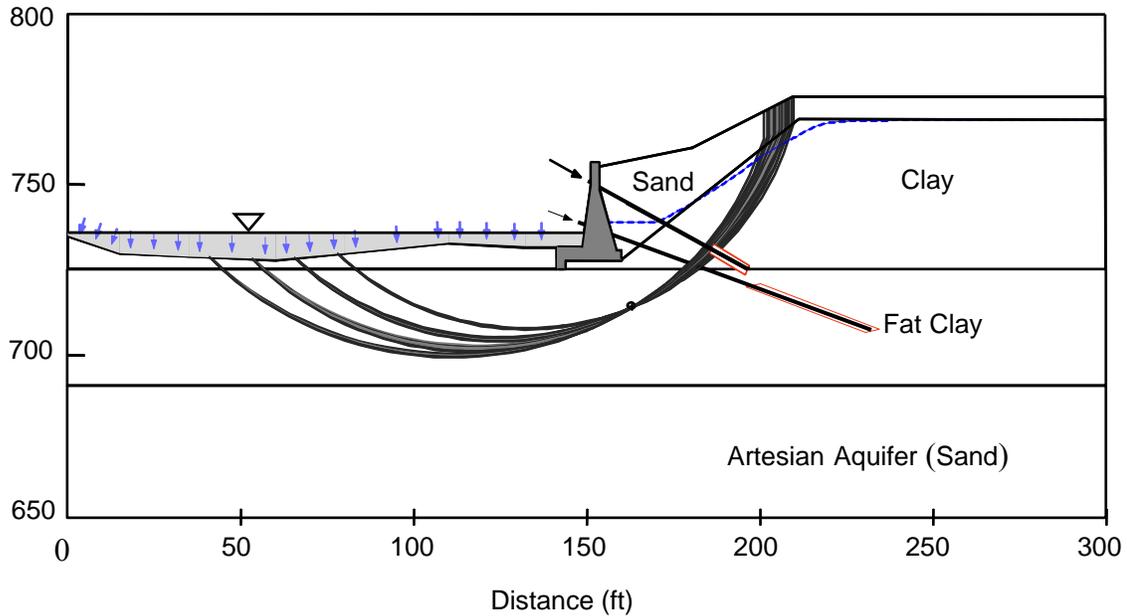
FIG. 11. Typical Section through East Tailrace Wall with installed 2002 tiebacks looking Downstream.

Continuous movement of the wall prompted the 2002 remediation effort, which was conceived following the observation approach. The 2002 remediation consisted of tiebacks installed through the retaining wall and bonded beyond the critical slip surface determined from the inclinometer data as shown in Figure 11. One of the difficulties encountered during this design was the limited volume of soil available for tieback placement. The existing 1996 tiebacks did not allow the installation of the new tiebacks within the upper half of the wall. The artesian aquifer limited the inclination and length of the new tiebacks, which were not to be drilled into the aquifer. The tiebacks were then installed from the water line with relatively shallow inclinations. Details of the design and installation of these tiebacks are presented Bruce et al. (2007), Bruce et al. (2004), and Gomez et al. (2004).

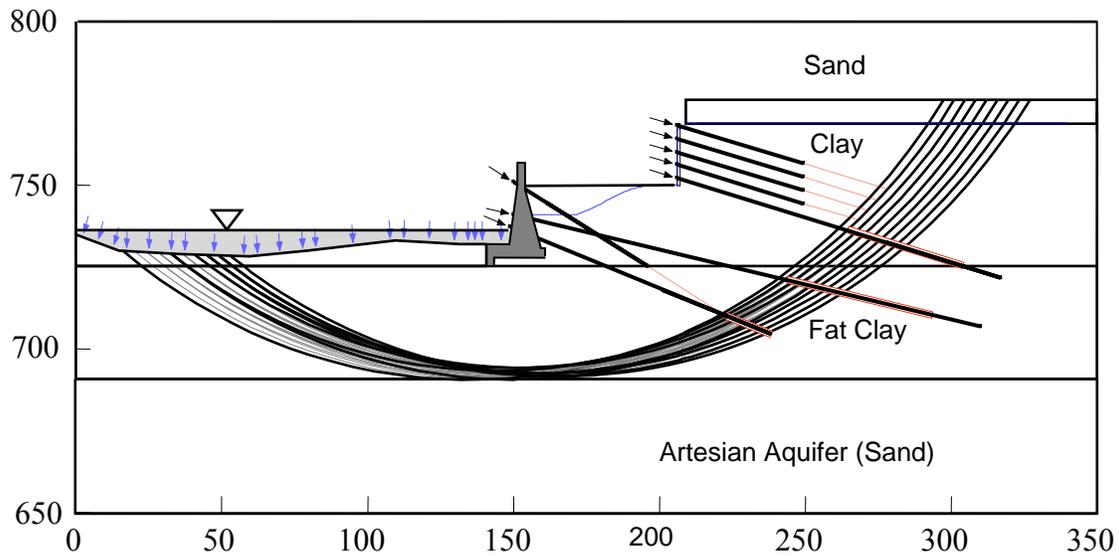
FIG. 12. Typical Section through East Tailrace Wall with 2009 Phase I and Phase II soil nails and tiebacks looking downstream.

Figure 12 also depicts potential deep slip surfaces where the factor of safety was increased by the remediation. The minimum factor of safety was 1.54, which met the minimum factor of safety of 1.5 specified by the Federal Energy Regulatory Commission (FERC). The tieback lengths were primarily driven by the effect of the artesian aquifer-induced pore pressures within the clay and the need to extend the bond zone beyond potential deep seated slip planes. Because the ratio between effective stress and depth is much lower than in a hydrostatic environment, there is a relatively small increase in drained shear strength with depth.

The last remediation effort was completed in two phases and is depicted in Figure 12. The first phase of the remediation was to further stabilize the known failure mass. The second phase of the stabilization was to increase the safety margin against a future deep failure mass. As part of the Phase I remediation in 2009, a significant volume of soil was excavated from above and behind the wall. This was accompanied by the construction of a soil nail wall adjacent to the existing switch yard, and the installation of 125 ft long soil nails at the base of the soil nail wall. The purpose of the soil nail wall was to provide stability to the substation and included drainage elements to reduce pore pressures in the clay behind. The length of the bottom row of soil nails was set at 125 feet to increase the factor of safety against potential deep-seated failure.

In 2010, the second phase was completed, which consisted of tiebacks installed through the existing retaining wall and through the downstream sheetpile wall to further increase the factor of safety against slope instability. The monitoring data collected shows that the movement of the wall has stopped, or reversed in some instances.

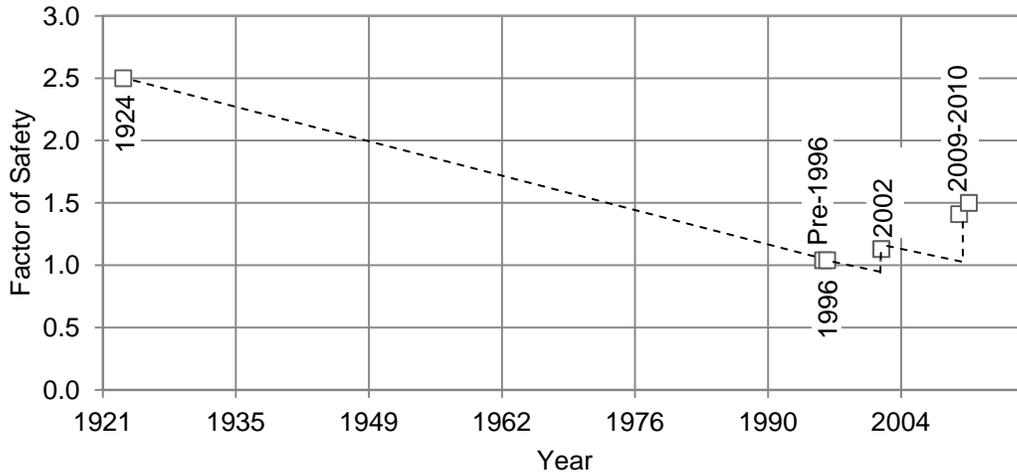
Figure 13 depicts the variation of the factor of safety over time since construction of the East Tailrace Wall. All the values in the plot are based on finite element analyses except the initial factor of safety from 1924. The initial factor of safety was estimated based on the undrained shear strength of the clay determined from the test results shown in Figure 9. This estimated factor of safety is not likely accurate because it is based on recent shear strength tests, and because it does not consider the presence of fissures in the clay, among other factors. However, it does serve to illustrate that the wall was stable immediately after construction.

The factor of safety decreases continuously over time until 2002, when the second remediation effort was carried out. The introduction of tiebacks through the wall increased the factor of safety to a value of 1.13. This factor of safety was

calculated using residual strength parameters for the clay and introducing the apparent cohesion to account for three dimensional effects as described previously. The factor of safety value is low compared to the factor of safety of 1.34 considered during the design of the 2002 tiebacks. It is noted that the line depicting the decrease of factor of safety after construction of the wall is only indicative of the average rate of decrease of the factor of safety.

FIG. 13. Variation of factor of safety with time

Figure 13 shows the increase in factor of safety during the 2009-2010 remediation. The largest increase in factor of safety was due to removal of soils during Phase I. The significant increase in the estimated factor of safety during the 2009-2010 remediation event is supported by the data presented in Figures 14 and 15. The wall experienced reversal of the direction of movement, and the load of the existing 2002 tiebacks decreased significantly. This reversal of movement and decrease in tieback loads is still ongoing.

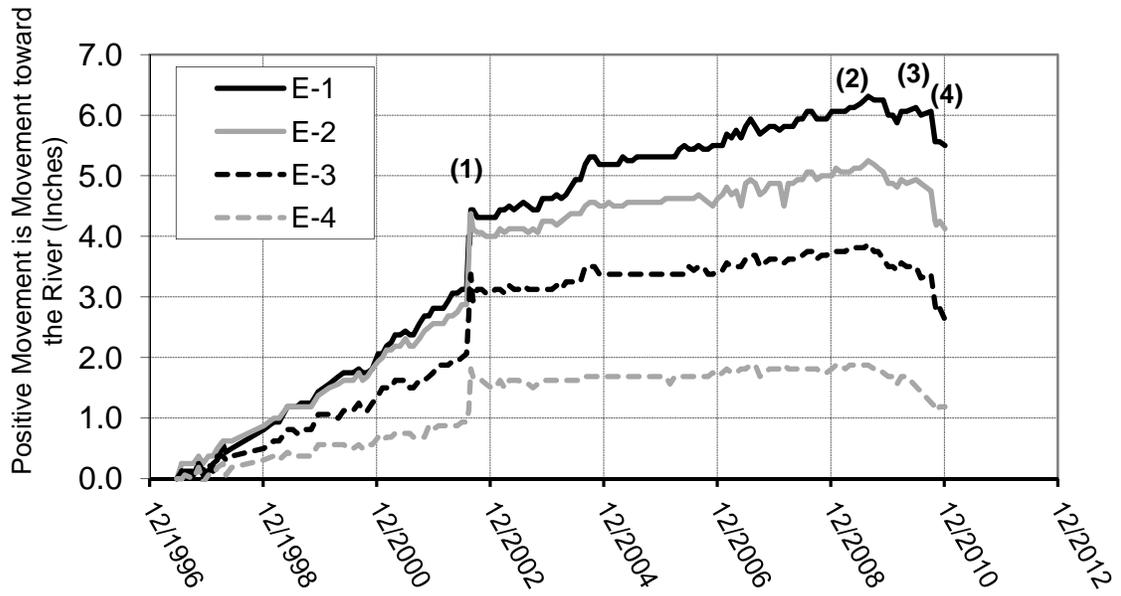
Figure 14 shows the wall displacement over time. The following events are depicted in the figure:

- (1) Tie-back construction period and dewatering was from about 7/18/02 to 9/9/02
- (2) Start of Phase I of the 2009-2010 remediation
- (3) Start of Phase II remediation
- (4) Completion of Phase II remediation

The data in the figure shows that movement of the wall stopped for approximately six months to one year after installation of the 2002 tiebacks. The movement then resumed although at a significantly slower rate. The 2002 remediation monitoring/action plan required, among other things, periodic monitoring of the tension load of the 2002 tiebacks. The tieback load was measured through lift-off testing as described by Bruce et al. (2007), Bruce et al. (2004), and Gomez et al. (2004).

FIG. 14. Movement of the east downstream retaining wall cap, since 6/23/97. (See Figure 4 for location of monitoring points).

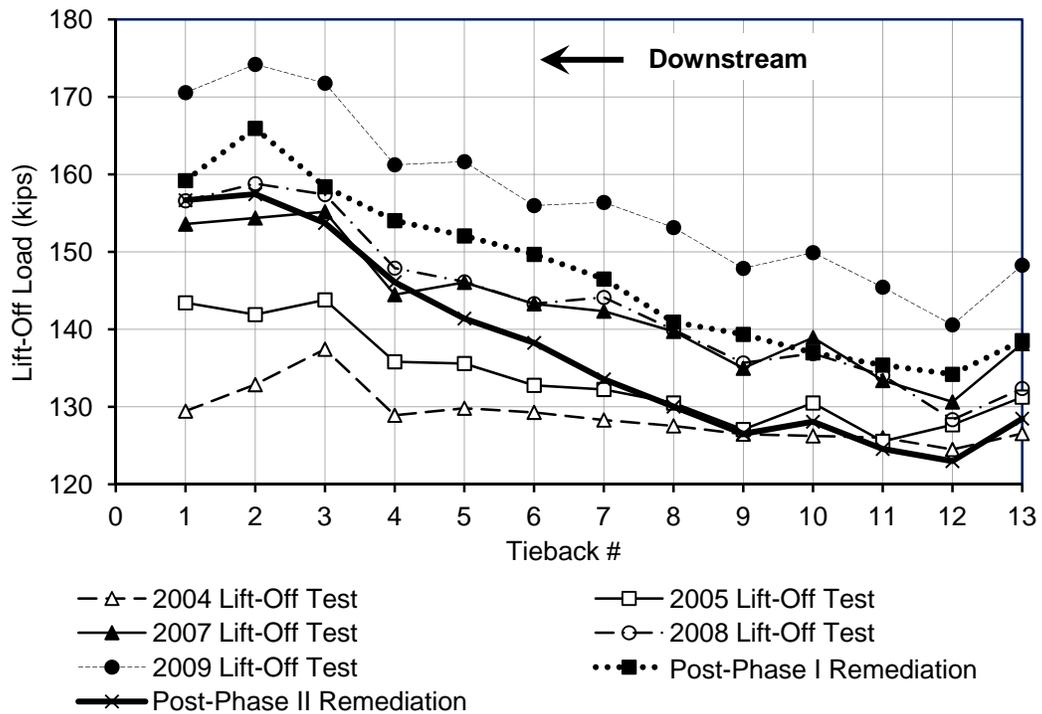
Figure 15 shows the results of the lift-off test measurements. It is seen that the loads of the 2002 tiebacks increased progressively since their installation as the wall moved outward. Careful analysis of these data showed that the tiebacks were bonded outside the sliding mass, and that they were not yielding geotechnically.

FIG. 15. Results of Lift-off Testing of SBMA Anchors

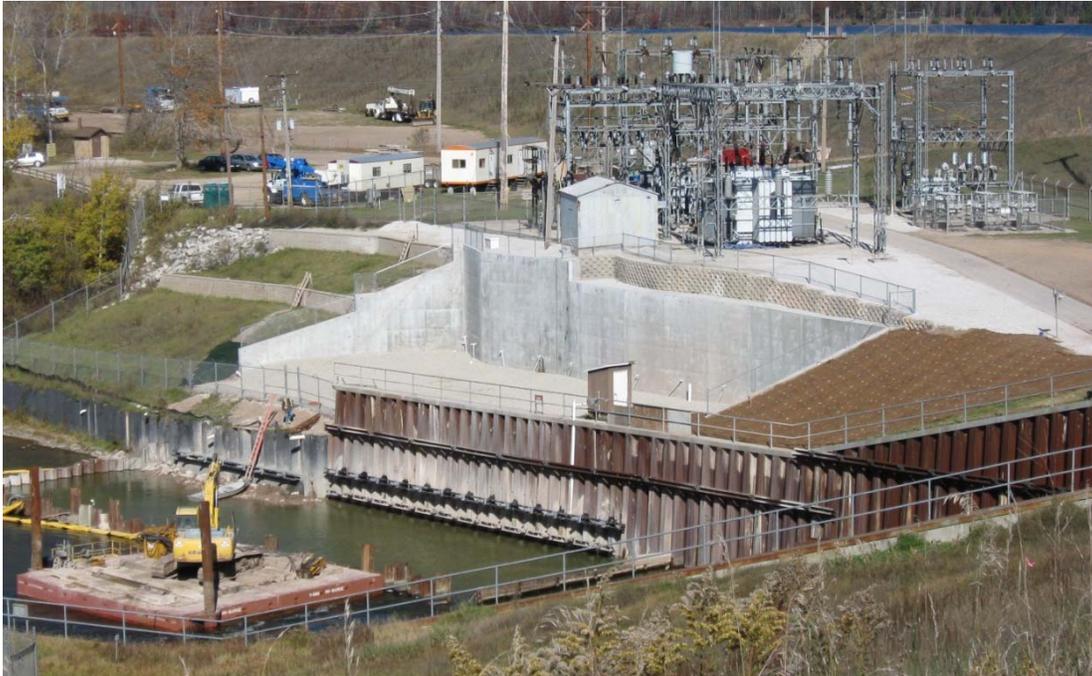
FIG. 16. View of the tailrace channel and east retaining wall. Note the tiebacks from top to bottom, installed in 1996, 2010, and 2002.

The Phase I excavation extended five feet below the top of the East Wall and about 48 feet behind the East Wall. A soil nail wall was installed to retain the face of the excavation next to the existing substation. The second phase of the slope stabilization included installation of shallow tiebacks through the retaining wall and anchored behind a potential deep seated failure plane. A photograph of the final condition is shown in Figure 16.

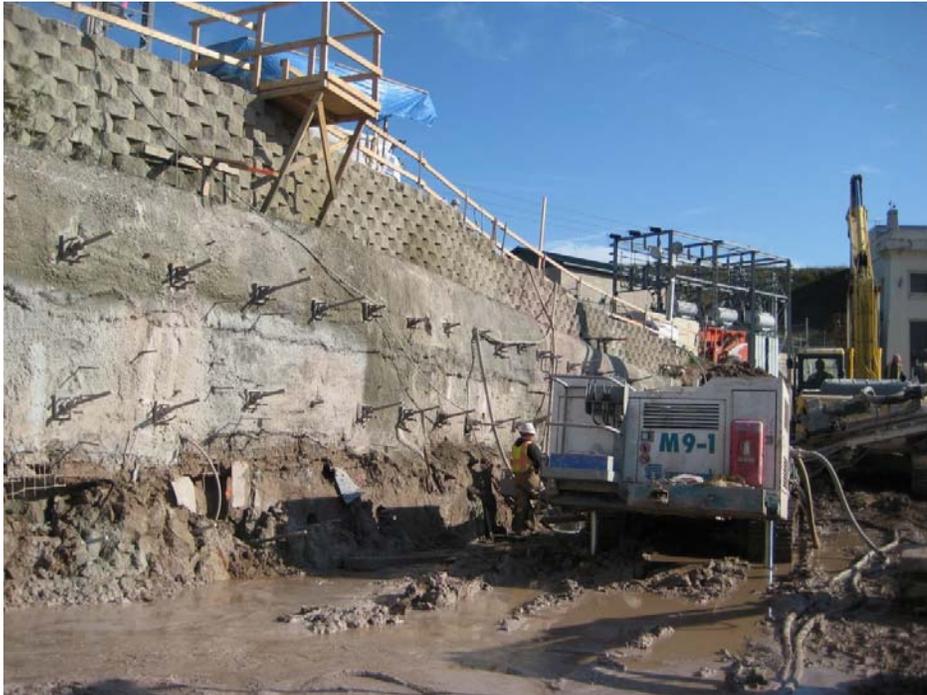
FIG. 17. Soil nail wall during construction with temporary shotcrete face applied.

The soil nail wall facing varies in height up to 26 ft. The upper rows of the soil nails ranged in length from 20 to 50 ft and were double corrosion protected. The bottom row of soil nails were 125 ft long to provide additional resistance to deep seated failures. The design considered a factor of safety of 2.0 for bond with confirmation through verification and proof load testing. The soil nail wall was designed assuming that full water pressure develops behind the wall, in addition to potential ice lensing in the lean clay adjacent to the soil nail wall face. Drainage panels were placed behind the shotcrete, and perforated PVC pipe drains were installed in predrilled holes through the excavation face. Figure 17 shows a photograph of the soil nail wall during construction.

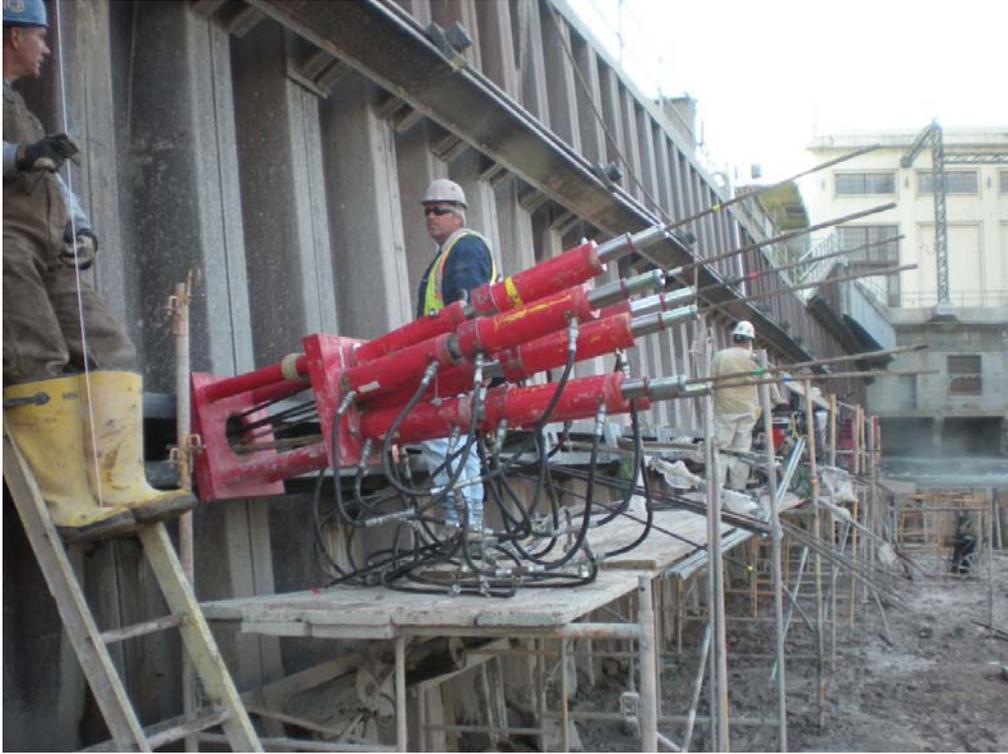
FIG. 18. Photograph of the performance and proof load test setup for the SBMA anchors.

spacing. They extended 165 ft behind the wall. The tiebacks are composed of six 7-wire strand Class 1 corrosion protected Single Bore Multiple Anchors (SBMAs). A photograph of the performance and proof load test setup is shown in Figure 18.

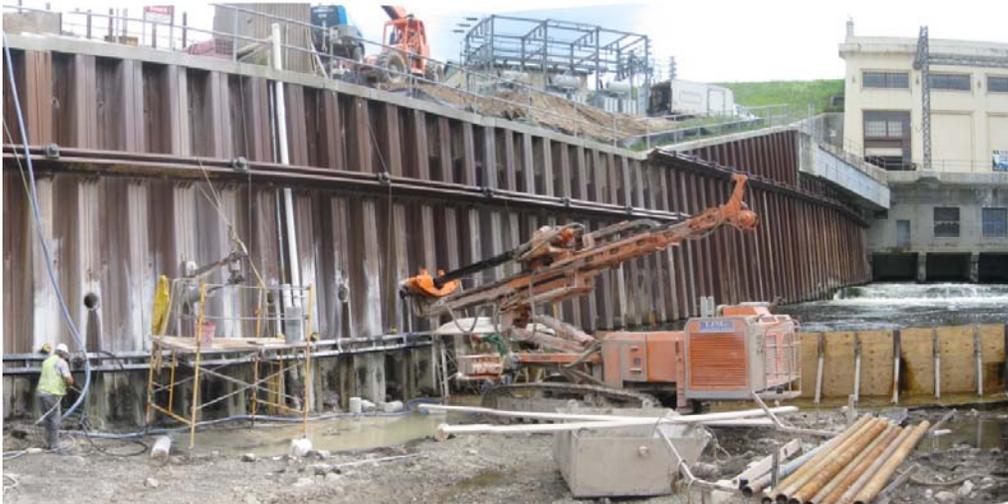
FIG. 19. Photograph of the coring and tieback installation through the tailrace wall.

Coring through the 5 to 7 ft thick concrete wall was performed prior to duplex drilling. Rotary drilling of the concrete wall was not performed due to limitations on the hole trajectory tolerances. The core hole provided a guide for installation of the long tiebacks. A photograph of the coring and tieback installation within the cofferdam is shown in Figure 19.
