PERFORMANCE OF DAMS AND SPILLWAYS – 2009 GEORGIA FLOOD

*Randall P. Bass, P.E.¹,
James R. Crowder, P.²
Joseph S. Monroe, P.E.³*

ABSTRACT

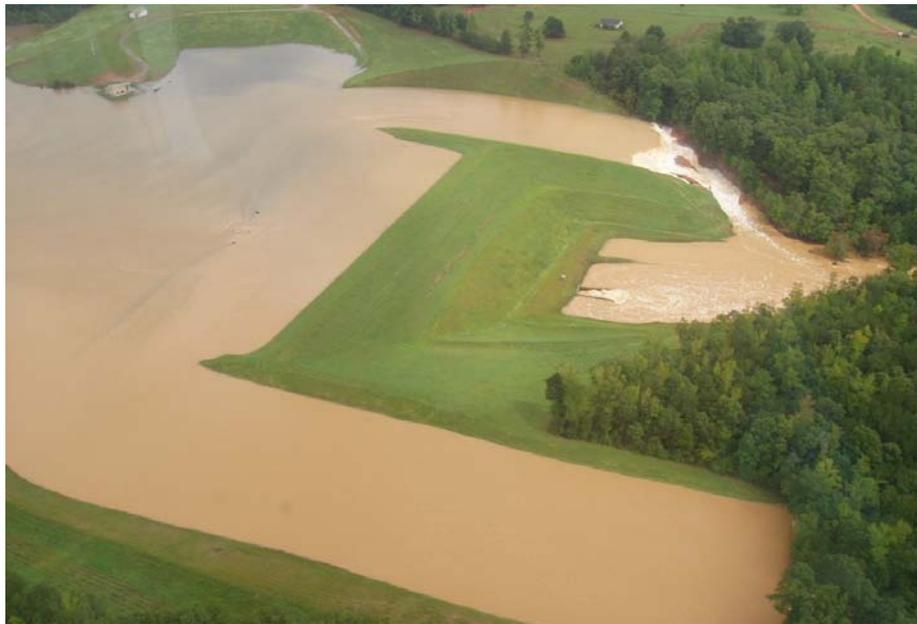
The drainage basin contributing runoff to Snake Creek reservoir received approximately 13 inches of rain in a 12 to 15 hour period during the September 2009 flood event. The resulting runoff activated both of the auxiliary spillways. Figure 6 provides an aerial view of the Snake Creek Dam with both auxiliary spillways flowing. At the peak reservoir elevation, the depth of flow through the control section of the auxiliary spillways was estimated to be about 4 feet. Based upon available data, the rainfall amounts in the Snake Creek drainage basin approached, if not exceeded, one-third Probable Maximum Precipitation values. The runoff into the Snake Creek reservoir was increased by the failure of a relatively small dam and subsequent release of stored water.

Figure 6. Snake Creek Dam with Auxiliary Spillways Engaged

The entire spillway system for the Snake Creek Dam performed as designed with the right abutment auxiliary spillway experiencing little, if any, damage in the constructed inlet channel, control section, or outlet channel. The left abutment auxiliary spillway, while functioning as designed, did experience damage immediately downstream of the constructed

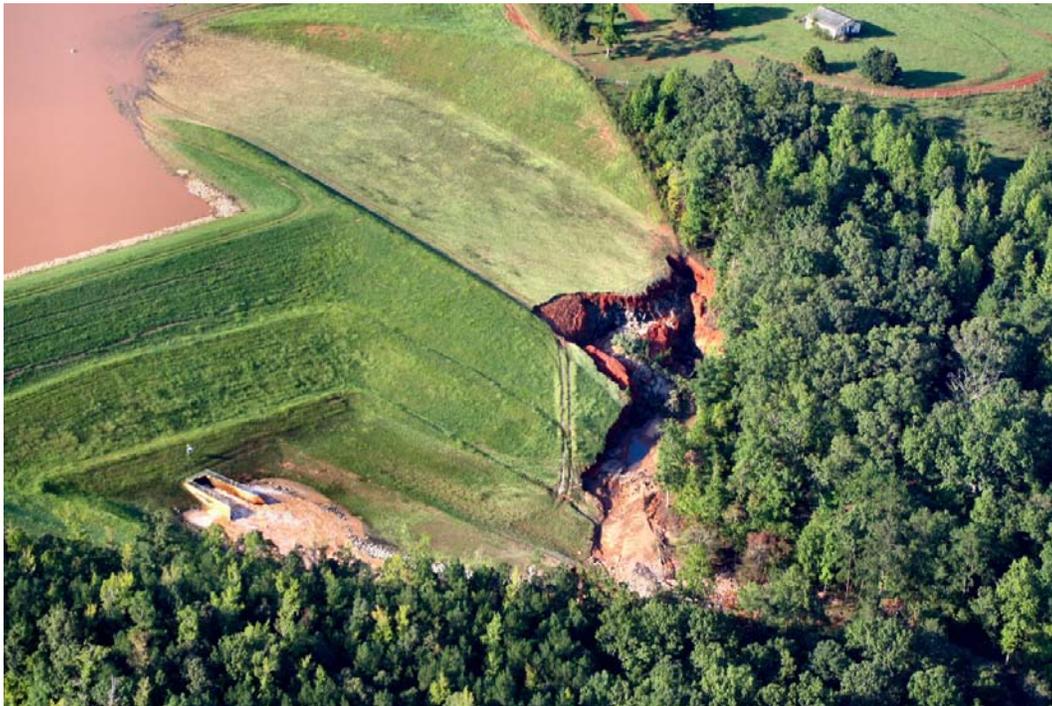
outlet channel. As modeled utilizing the SITES computer program, the left abutment auxiliary spillway was determined to be more erodible than the right spillway. The damage that occurred during the September 2009 flood event was largely the result of the left abutment auxiliary spillway being discharged into a swale or draw that conveyed flow at a 70 to 80 degree angle to the alignment of the spillway. The abrupt change in flow direction, as well as the presence of trees that cause erosion generating eddies, resulted in the damage downstream of the constructed outlet channel shown in Figure 7.

Figure 7. Damage to the left auxiliary spillway of the Snake Creek Dam

The owners of the Snake Creek Dam and Reservoir are currently repairing the damage to the spillway by extending and straightening the outlet channel of the left abutment auxiliary spillway, as well as backfilling the eroded areas with structural fill. Repairs to the spillway are scheduled to be completed in the winter of 2010-2011.

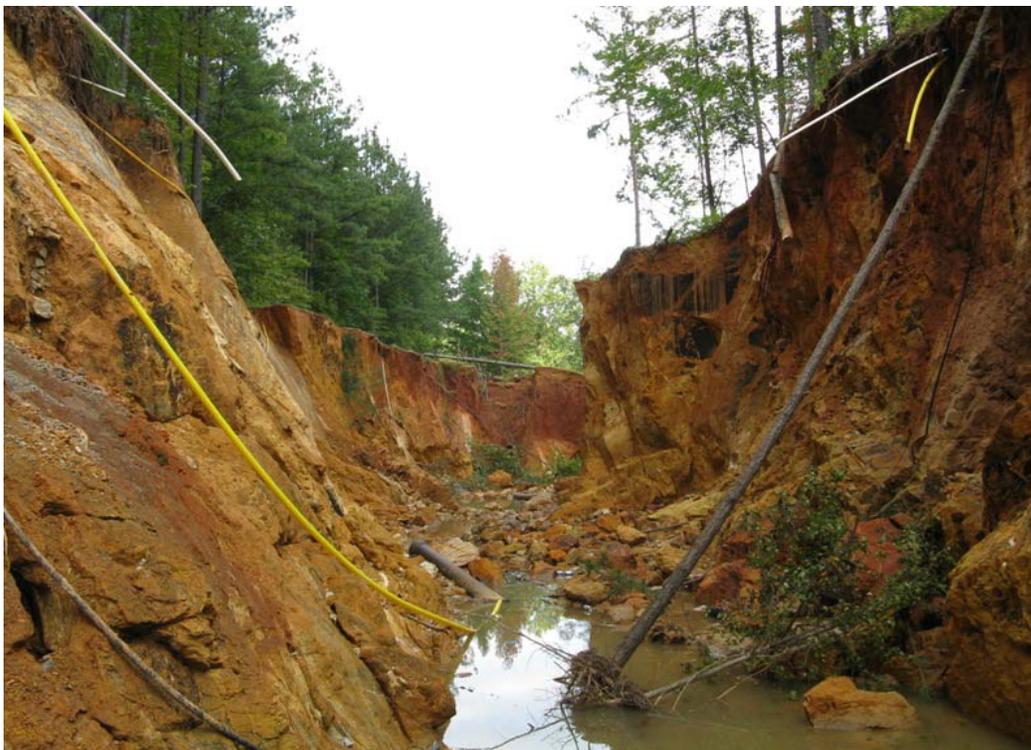
During the intense rainfall of September 2009, the auxiliary spillway activated. A flow depth through the auxiliary spillway of approximately three feet was estimated by NRCS personnel. The duration of flow through the existing auxiliary spillway was estimated by NRCS personnel to be about 20 hours. During this flood event, the auxiliary spillway eroded over 20 feet deep at the control section (Figure 8). Erosion in the auxiliary spillway exposed a sanitary sewer line that had been constructed through the abutment of the dam and followed the flow path of the auxiliary spillway.

Figure 8. Photograph of Eroded Auxiliary Spillway Channel at Pumpkinvine Creek Watershed Dam No. 3

The results of the SITES analyses indicated that the auxiliary spillway for the Pumpkinvine Creek Watershed Dam No. 3 functioned as modeled (i.e. the extent of the headcut damage was reasonably well predicted by the SITES computer model). Given the presence of the sanitary sewer backfill and other geotechnical and hydraulic discontinuities, less correlation between the SITES model and the actual performance was anticipated. We note, however, that the spillway would have likely functioned better (i.e. experienced less erosion) had the sanitary sewer been constructed in another location and the spillway been founded in competent native residual soils as intended during the original design.

Repairs to Pumpkinvine Creek Watershed Dam No. 3 have been designed and approved by both the NRCS and the Georgia Safe Dams Program. Repairs to the spillway are scheduled to be completed in the winter of 2010-2011.

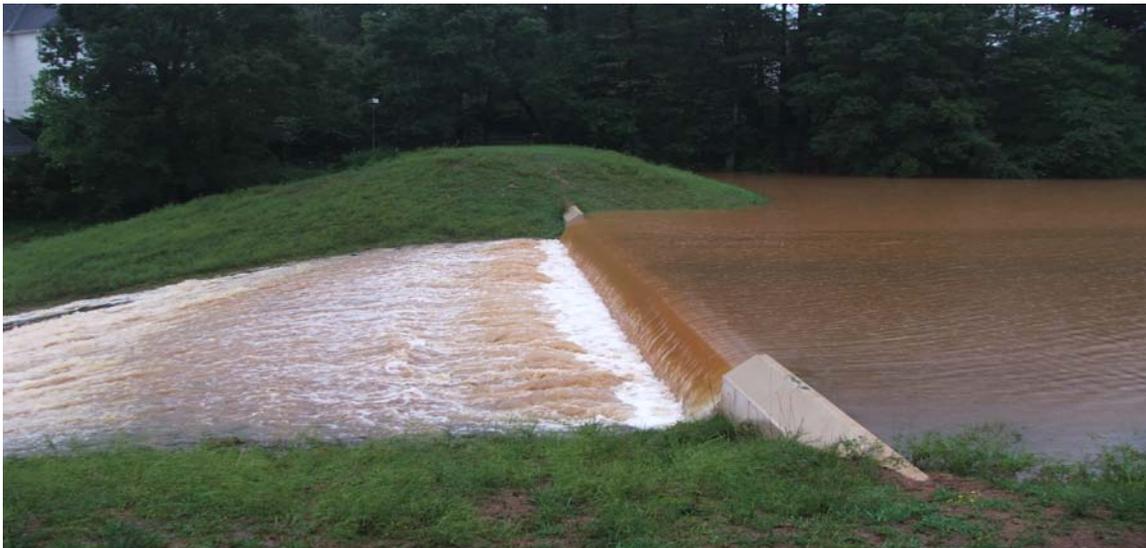
Figure 10. Looking from Left Side of Y-16 Dam on the morning of 21 September 2009

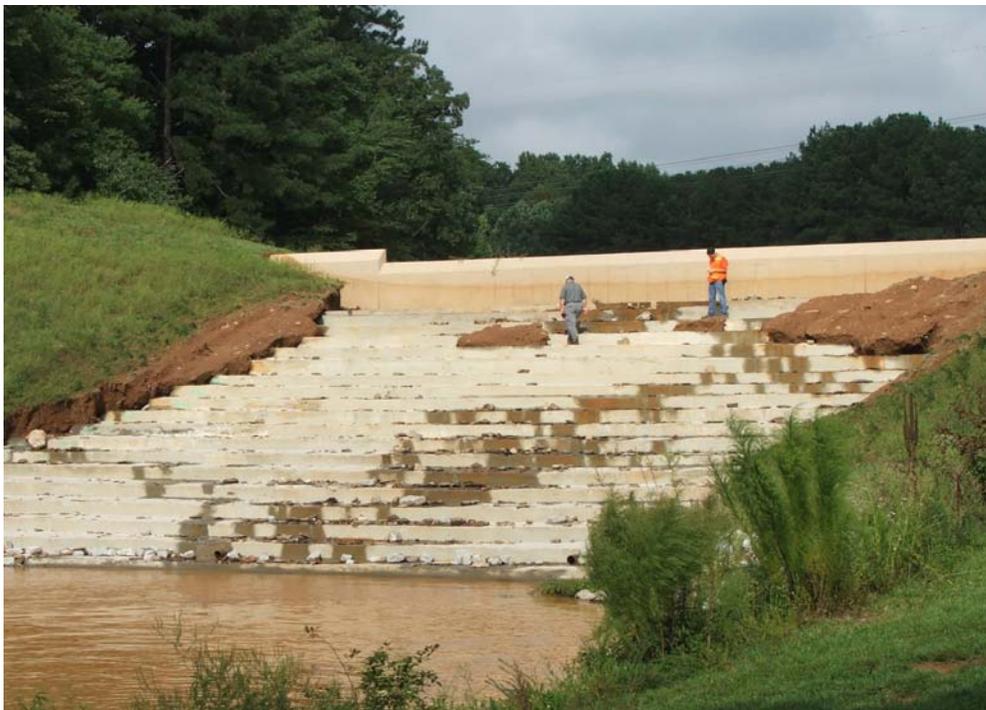
Damage to the spillway was limited to the removal of grass and topsoil. As shown in Figure 11, the spillway activated and a portion of the topsoil and grass were removed. Based upon photographs taken during the peak of the flood event and observations made subsequent to the flooding event, only the low-stage sharp crested weir was engaged (Figure 10). Given that the crest of the low-stage weir was established at the 25-year water surface elevation and the crest of the high-stage weir at the 100-year elevation, the observed conditions (i.e. activation of the low-stage but not the high-stage) match the rainfall that was observed in the region.

Figure 11. Photograph of Yellow River Watershed Dam No. 16 Auxiliary Spillway

Based upon the results of the hydrologic modeling and the observations made by representatives of Schnabel, the Y-16 dam performed as designed, with the only required

repairs being the placement of topsoil and reestablishment of acceptable vegetation. Figure 11 shows the exposed RCC and the area that will be re-vegetated.
